Station Surveys – Outer Harbor Line – June 2016

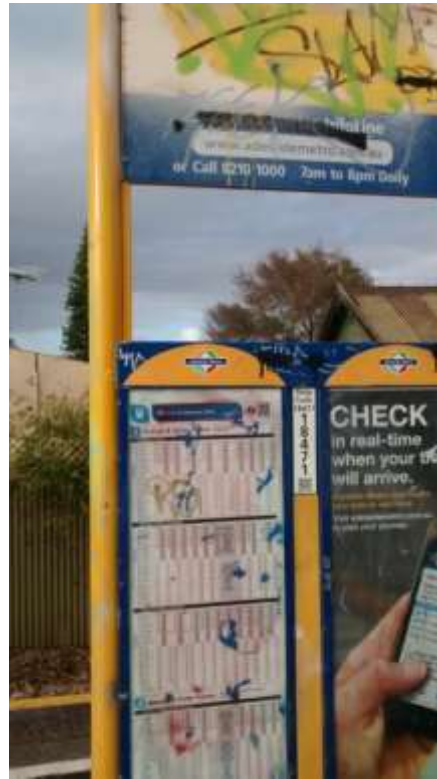
Photo 3.

STATION	PETERHEAD	
CRITERIA	SCORE (1 to 10)	COMMENTS
Appearance and Maintenance <ul style="list-style-type: none"> • Paintwork condition • Graffiti • Rubbish disposal • Cleanliness • Smells • Signage • Other 	3	<p>Some graffiti on timetables which in this instance obscures some of the information (Photo 3). Also graffiti on the seating (Photo 11).</p> <p>As advised by patron, fence on eastern side recently repainted to hide graffiti. Similarly, the main station sign was recently cleaned up (Photo 2).</p> <p>One older style rubbish bin (Photo 1).</p> <p>The station was generally clean, and no smells were apparent.</p>
Security, Safety & Lighting <ul style="list-style-type: none"> • Emergency call phone • Security Cams • Hidden areas • Oversight by neighbours • Underpass • Pedestrian Gates • Lighting - on Approaches • Lighting - on Platform 	3	<p>No emergency phone is present.</p> <p>Security camera is built into PA post, but as it is not evident, cannot provide a visual deterrence.</p> <p>No oversight of the platform from either the eastern side (Photo 4) or most of the western side (Photo 5), due to number of hedges and trees. There are a number of houses immediately adjacent to the car park and this well overseen by neighbours (if at home).</p> <p>Lighting is adequate on the platform but approaches only have minimal street lighting.</p>

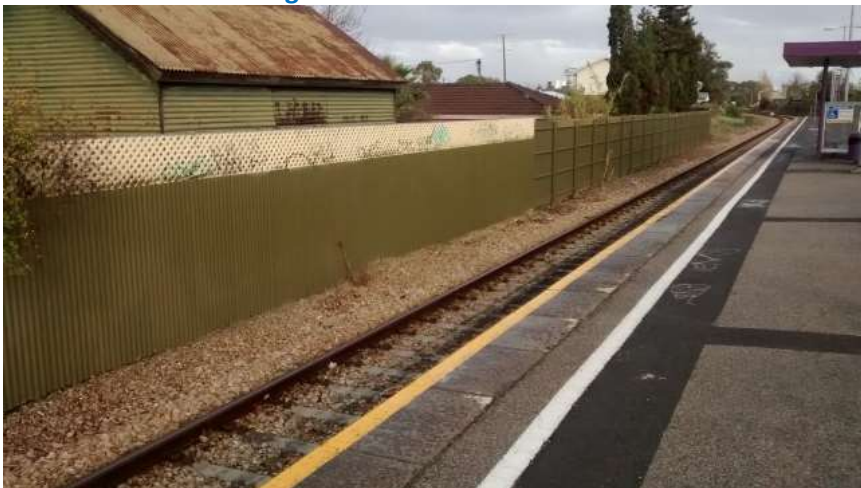
Photo 4. Eastern oversight

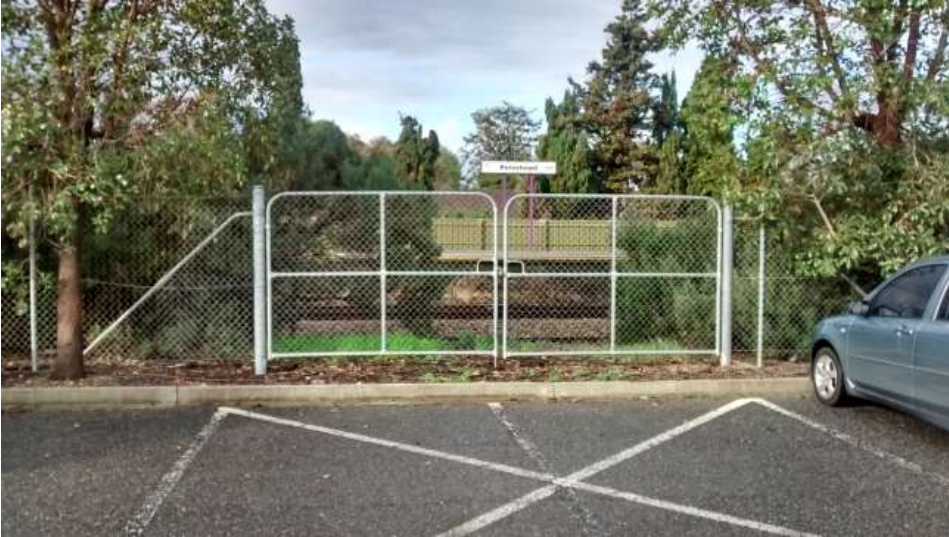
Photo 5. Western oversight

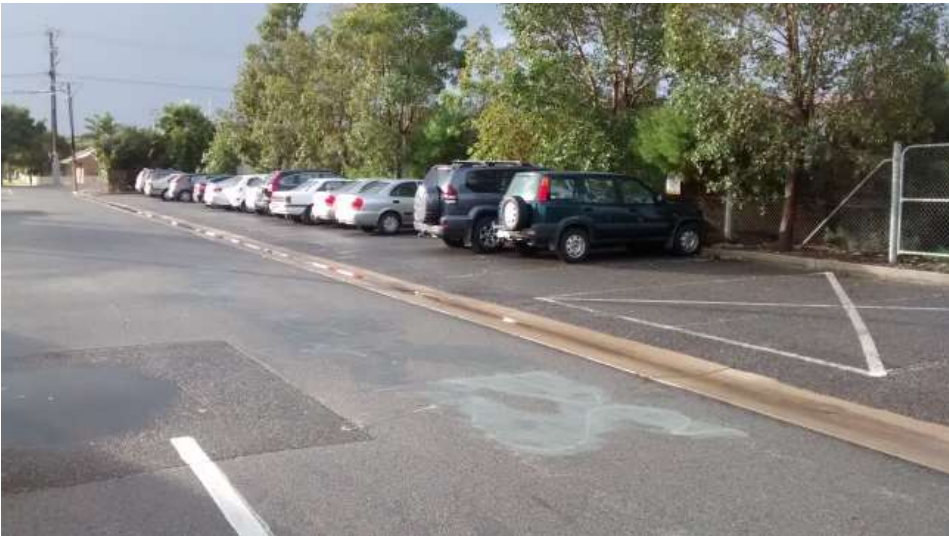
Car and Bike Parking <ul style="list-style-type: none"> • No of Spaces per Mode • Asphalt or gravel? • Bike chain-up secure? 	7	<p>There are 29 car parking spaces, with two spaces for disability parking. There were a number of cars present (Photo 6) but during the survey (Saturday afternoon), no passengers were seen going to the carpark - some 15-16 persons were seen using station and all departed on foot.</p> <p>The “path” from the car park to the platform is in fact the access road (Photo 7). However, as the park is sited in a “no through road”, there appears to be minimal traffic risk.</p>
Disability Access <ul style="list-style-type: none"> • At Approaches • Ramps to platform • On platform 	3	<p>Pedestrian path from western side (near car park) is basic (Photo 7). The path from the eastern side has a degree of disrepair (Photo 8). The path across the tracks and access to the platform ramp is basic and may be difficult to navigate by wheelchair or gopher (Photo 9). The ramp is usable but basic (Photo 10).</p> <p>There is no disability access ramp on the platform but should be provided. The gap between the train level and platform level is noticeable when a train is at the station.</p>

Photo 6. Car Park

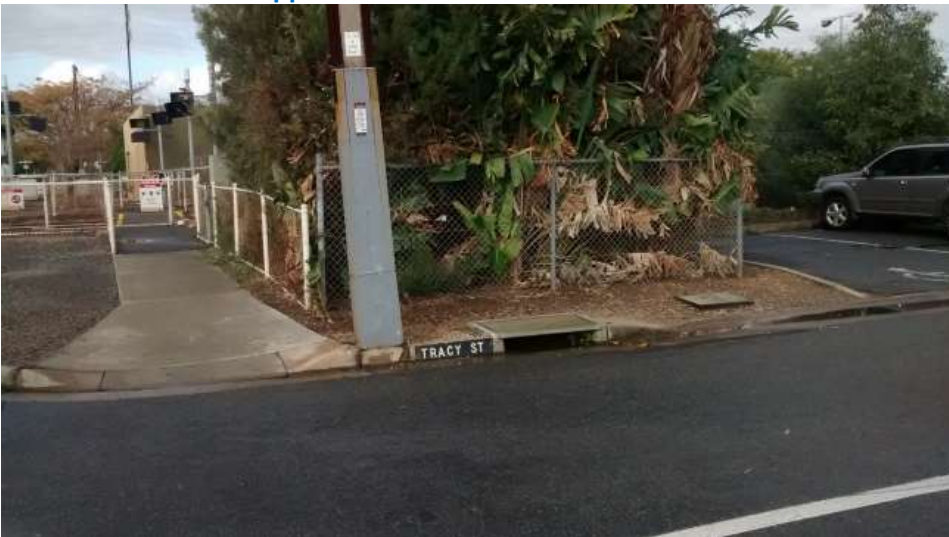
Photo 7. North West approach

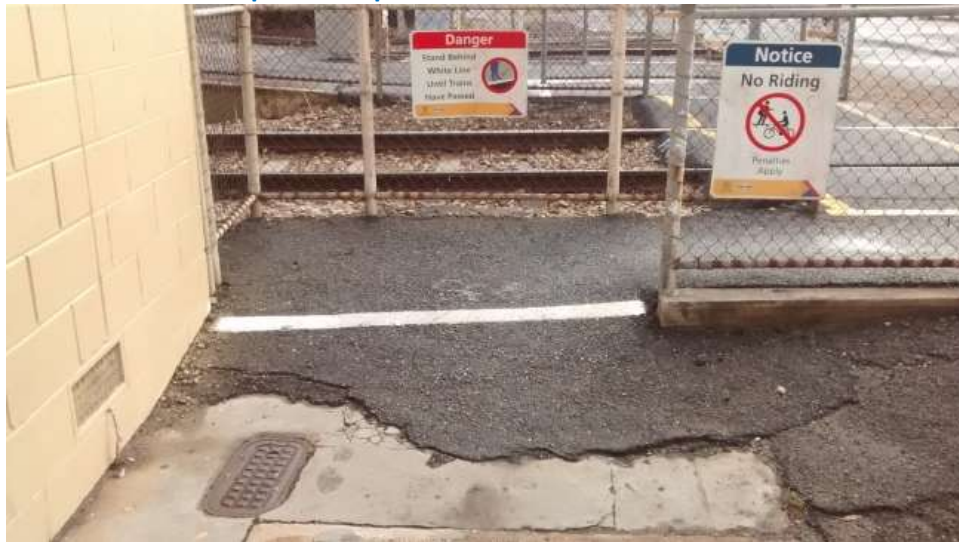
Photo 8. North East path disrepair

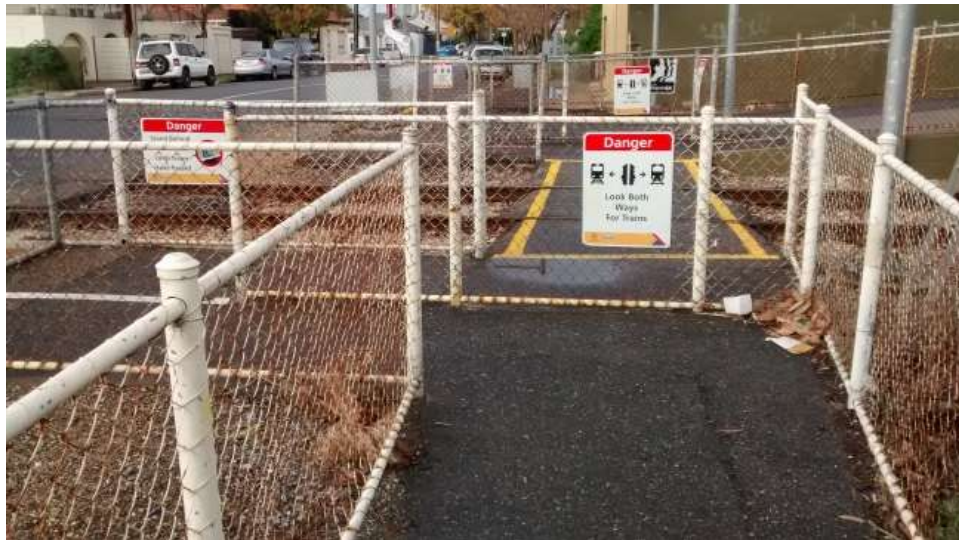
Photo 9. Path over tracks

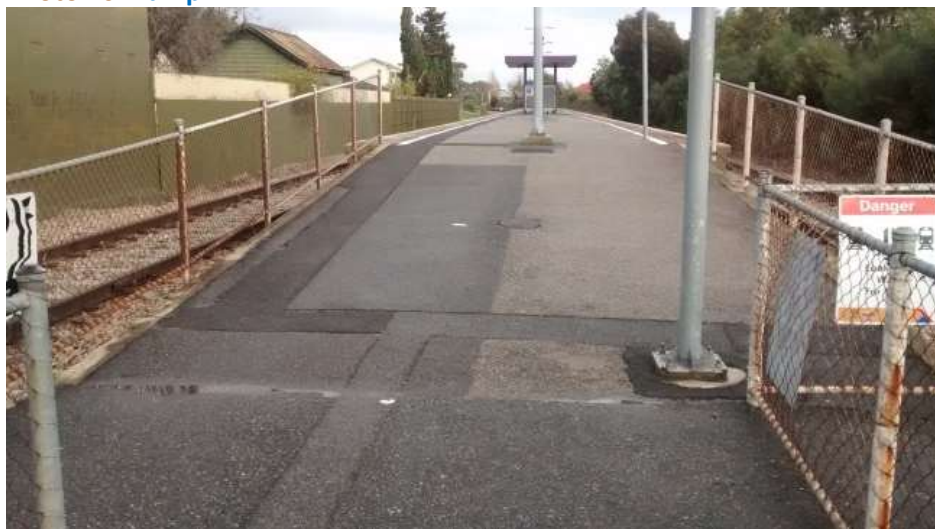
Photo 10. Ramp

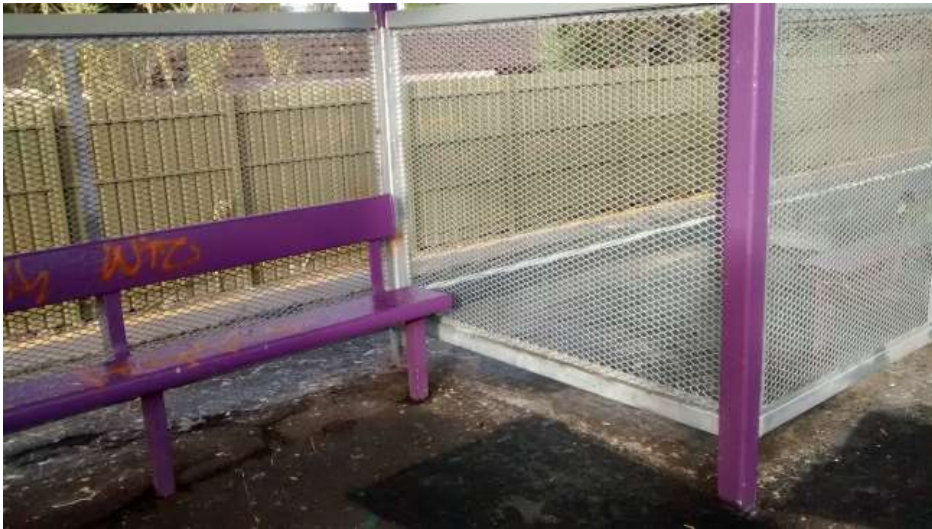
Facilities <ul style="list-style-type: none"> • Toilets • Seats • Food • Shade and Rain Shelter 	2	<p>There are no toilets or other amenities on the platform or nearby.</p> <p>As elsewhere on the line, the shelter is made of metal mesh but of a differing design (Photo 11). Shelter provides no wind protection whatsoever, and would appear to offer little protection from rain.</p> <p>Minimal degree of seating but there is a space for wheelchairs (Photo 12).</p>
Total Score / Overall Rating	3.6

Photo 11. Shelter

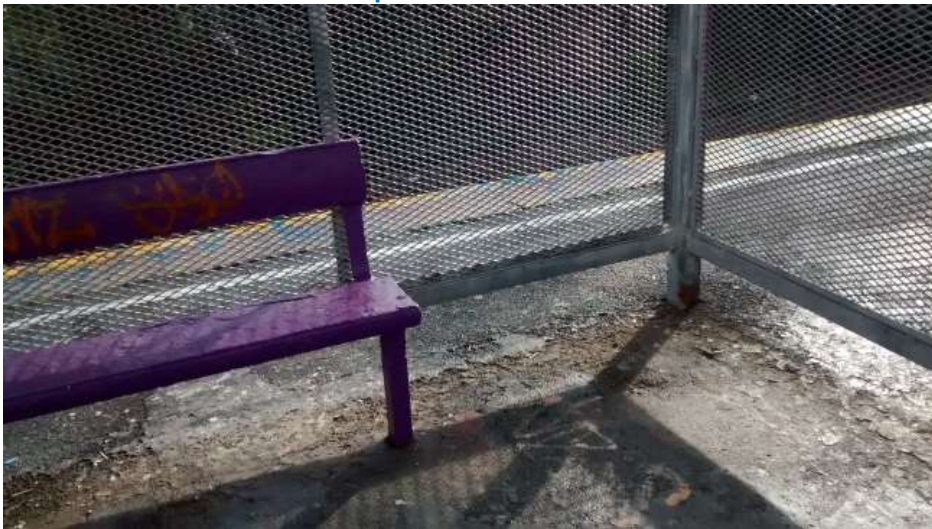
Photo 12. Shelter wheelchair spot
