Station Surveys - Outer Harbor Line – June 2016

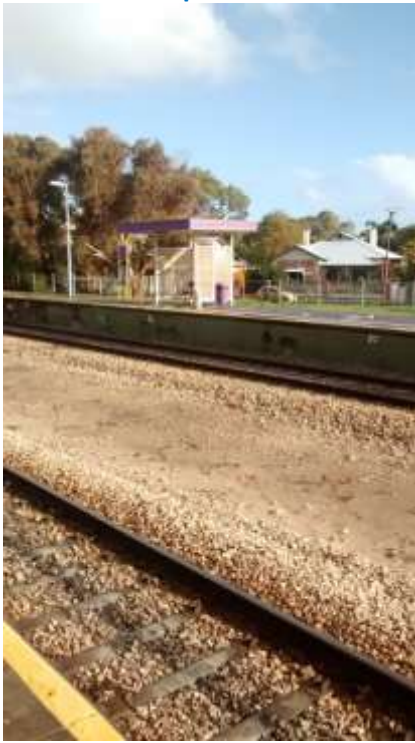
Photo 1. West platform

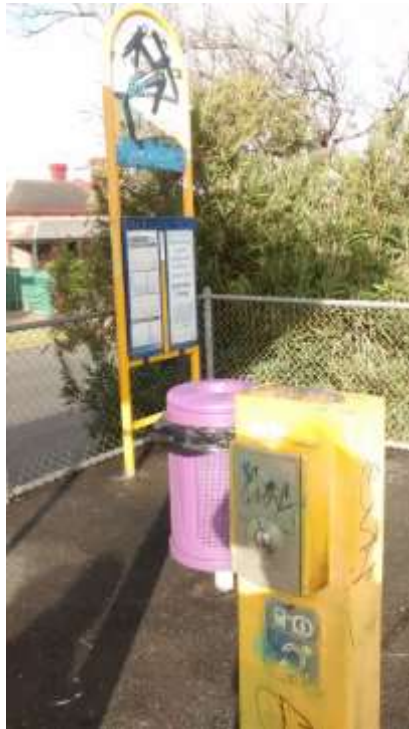
STATION	LARGS	
CRITERIA	SCORE (1 to 10)	COMMENTS
Appearance and Maintenance <ul style="list-style-type: none"> • Paintwork condition • Graffiti • Rubbish disposal • Cleanliness • Smells • Signage • Other 	5	Graffiti covers various signs on both platforms; however the timetables remain legible (Photo 3). Station generally clean, and no smells apparent. Small older style bin available.
Security, Safety & Lighting <ul style="list-style-type: none"> • Emergency call phone • Security Cams • Hidden areas • Oversight by neighbours • Underpass • Pedestrian Gates • Lighting - on Approaches • Lighting - on Platform 	5	No emergency phone is present. Security camera is built into PA post, but as it is not evident, cannot provide a visual deterrence. Some oversight by neighbours on the western side (Photo 4), but hedges behind the eastern platform obscure many parts of that platform. Lighting on platform is adequate on the platforms and also on some approaches, including (surprisingly) the path on the south-west which runs behinds the housing (Photo 5). Given the significant gap between east and west platforms, it is surprising that the eastern platform is somewhat narrow.

Photo 3. Graffiti

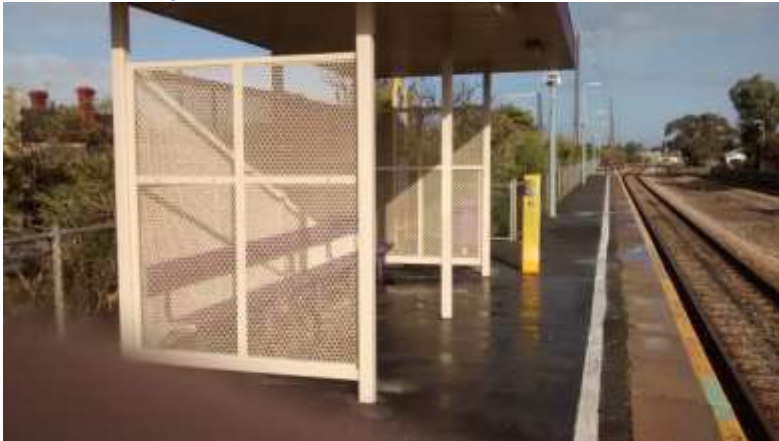
Photo 2. East platform

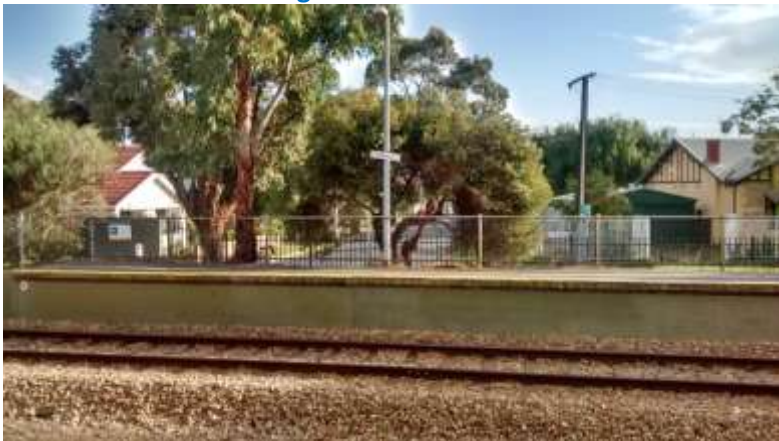
Photo 4. Western oversight

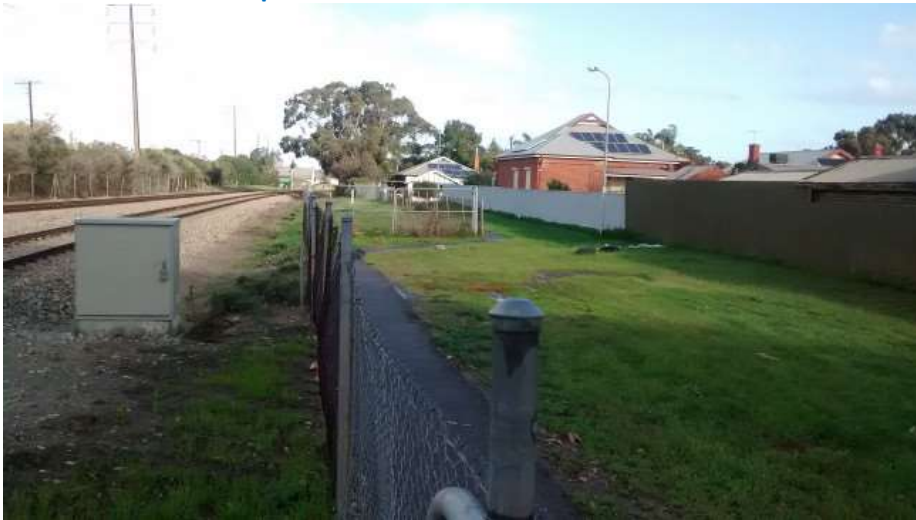
Photo 5. South West path

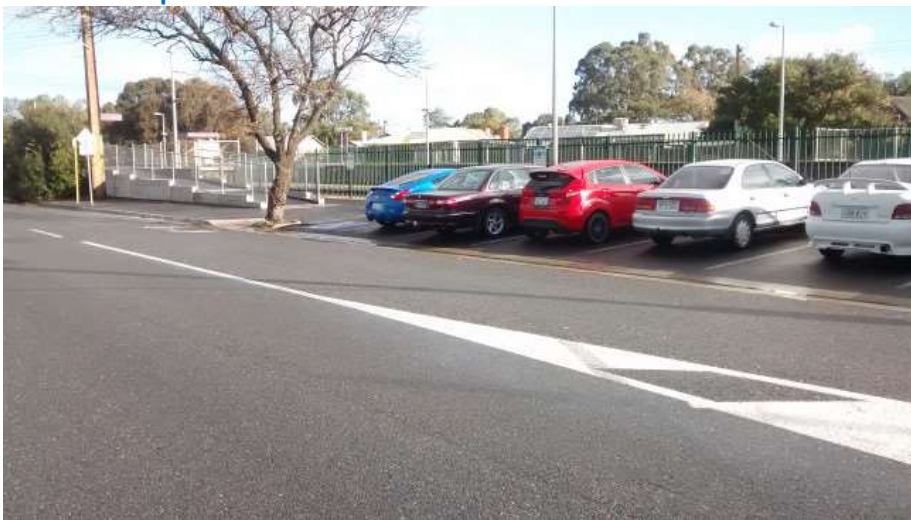
Car and Bike Parking <ul style="list-style-type: none"> • No of Spaces per Mode • Asphalt or gravel? • Bike chain-up secure? 	7	A well-placed car park of eight spaces (Photo 6) is provided with immediate access to excellent ramp to north-eastern platform (Photo 7). One car park space is reserved for disability purposes. Some street parking nearby. No bike rack
Disability Access <ul style="list-style-type: none"> • At Approaches • Ramps to platform • On platform 	6	Excellent ramp to north-east is matched by a good quality ramp to the western platform (Photo 11). However, access is let down in part by some disrepair to the north-western path adjacent to the track (Photo 8). Southern access ramps have not been upgraded to the same standard as the northern ramps and there is some unevenness (Photo 9). There are ramps on each platform to bring wheelchairs to level of train doors (Photo 10).
Facilities <ul style="list-style-type: none"> • Toilets • Seats • Food • Shade and Rain Shelter 	2	There are no toilets or other amenities on the platforms, or nearby. As elsewhere on the line, the shelter is made of metal mesh but of a differing design (Photo 2). Shelter provides no wind protection whatsoever, and would appear to offer little protection from rain. Minimal degree of seating with no space for wheelchairs (Photo 12).

Photo 6. Car park

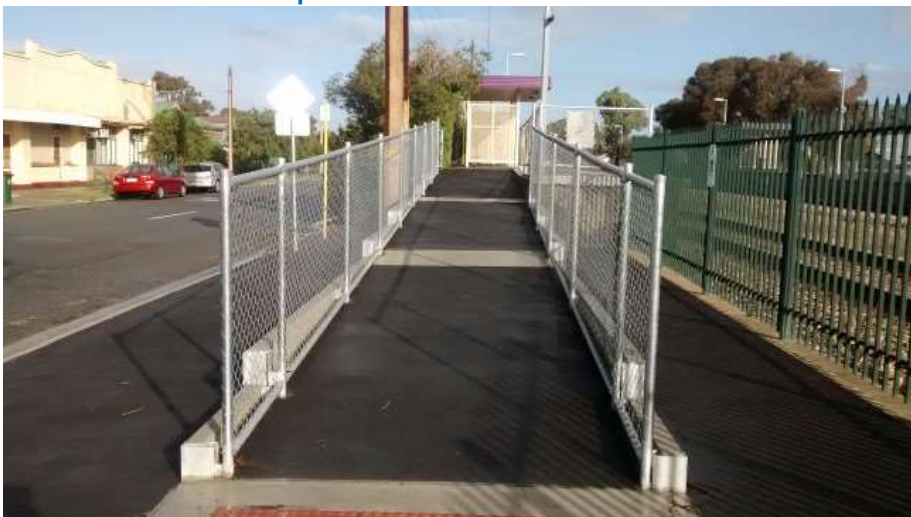
Photo 7. North East ramp

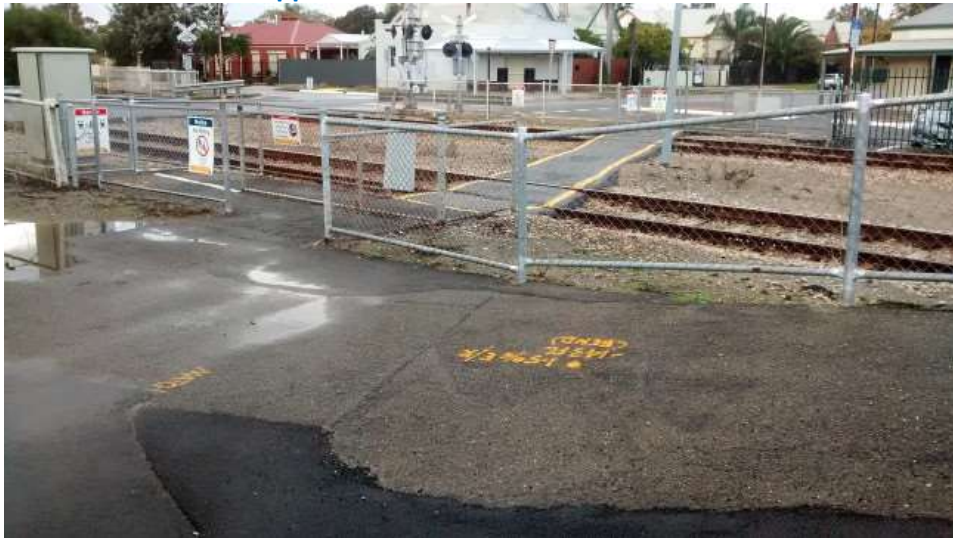
Photo 8. North West approach

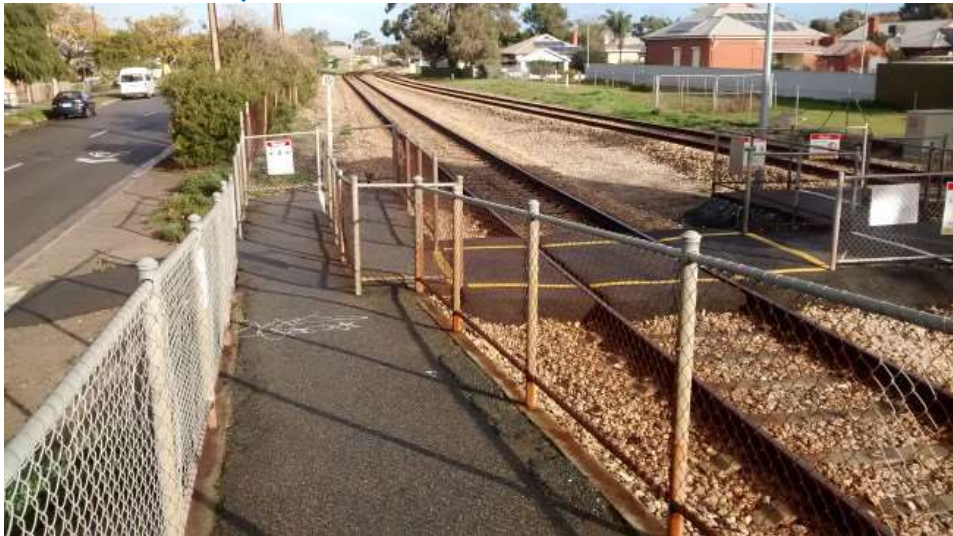
Photo 9. South ramp

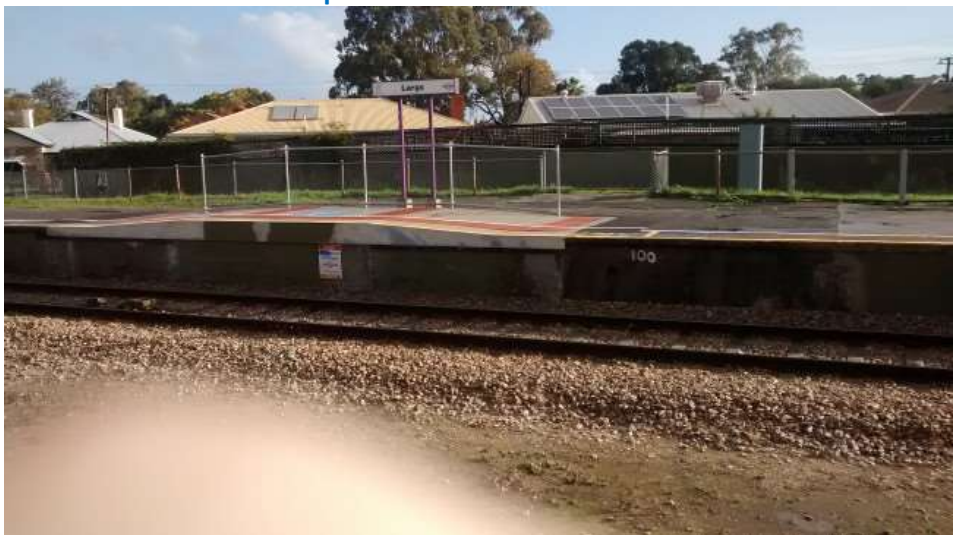
Photo 10. Wheelchair ramp

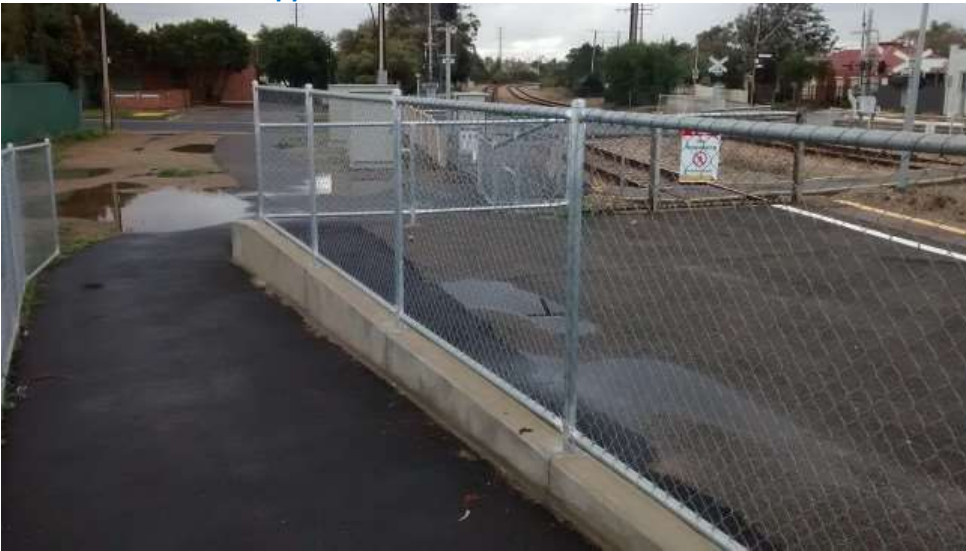
Photo 11. North East approach

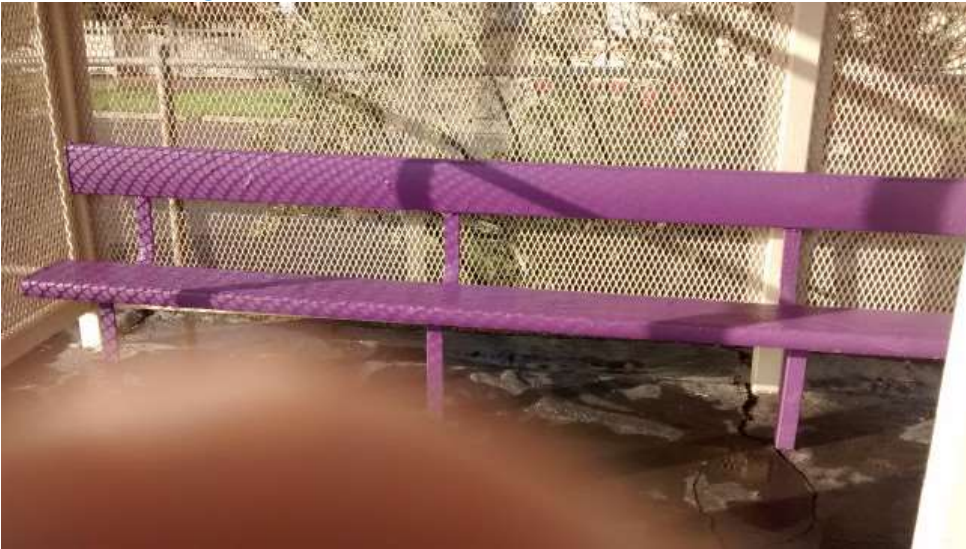
Photo 12. Seating
