Station Surveys - Outer Harbor Line – June 2016

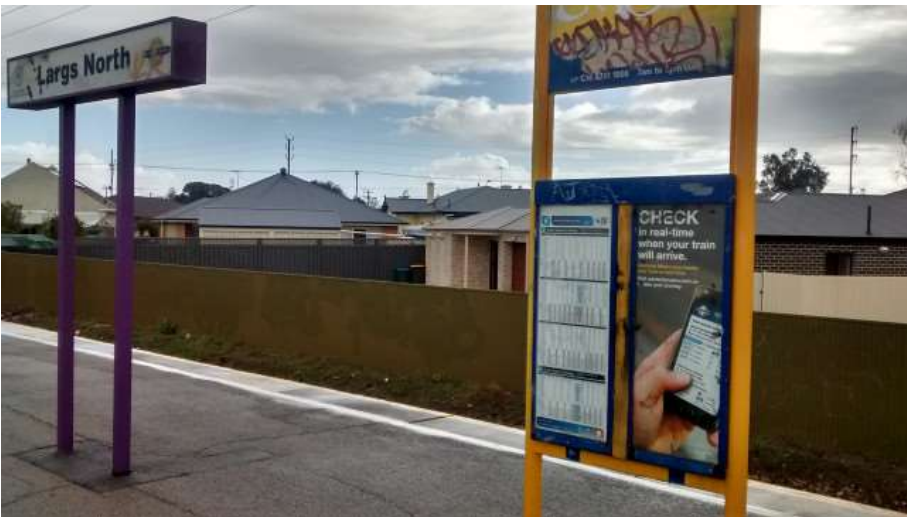
STATION	LARGS NORTH	
CRITERIA	SCORE (1 to 10)	COMMENTS
Appearance and Maintenance <ul style="list-style-type: none"> • Paintwork condition • Graffiti • Rubbish disposal • Cleanliness • Smells • Signage • Other 	6	<p>Some graffiti on the station and timetable sign, but timetable still legible (Photo 2). Signage includes route direction (Photo 3) which is rarely seen on this line.</p> <p>North-eastern access path leading from the RSL (Photo 4) is well paved, landscaped and has attractive murals. Artwork also evident from the south-eastern aspect (Photo 12).</p> <p>Good size and attractive bins available (Photo 9).</p> <p>Station is clean and no smells.</p>
Security, Safety & Lighting <ul style="list-style-type: none"> • Emergency call phone • Security Cams • Hidden areas • Oversight by neighbours • Underpass • Pedestrian Gates • Lighting - on Approaches • Lighting - on Platform 	5	<p>No emergency phone is present.</p> <p>Security camera is built into PA post, but as it is not evident, cannot provide a visual deterrence.</p> <p>Some oversight of platform from residences on the western side (Photo 2), but no oversight possible from the eastern side (Photo 5).</p> <p>Lighting on platform is adequate but may not be sufficient on the approaches e.g. it is not evident how well-lit at night is the path from the RSL.</p>

Photo 2. Graffiti

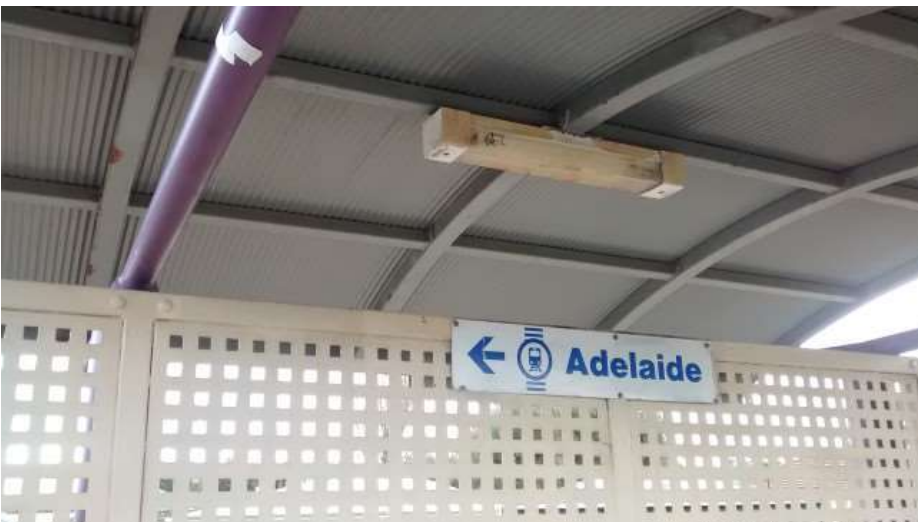
Photo 3. Directions

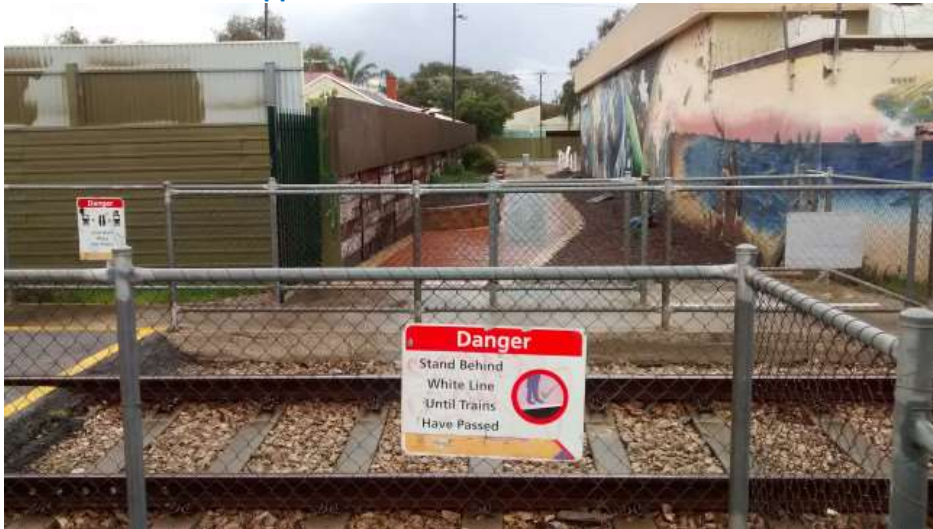
Photo 4. North East approach

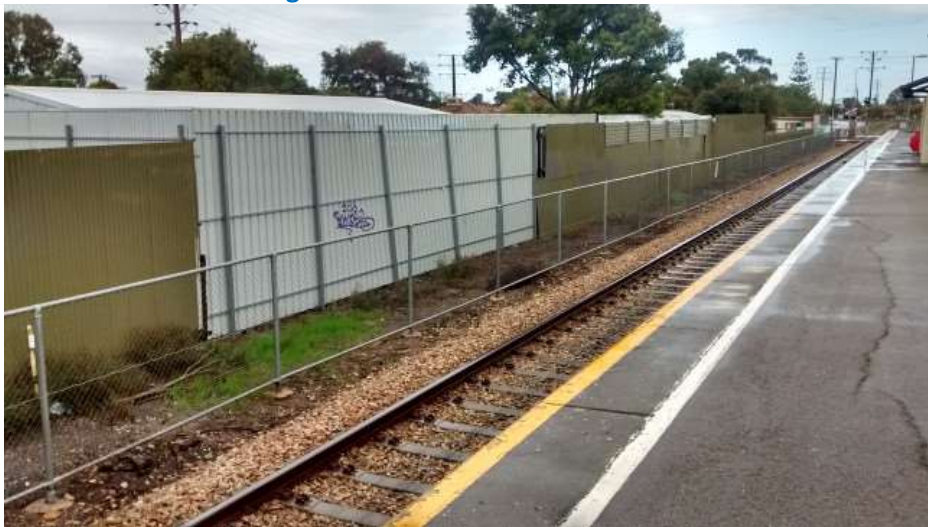
Photo 5. Eastern oversight

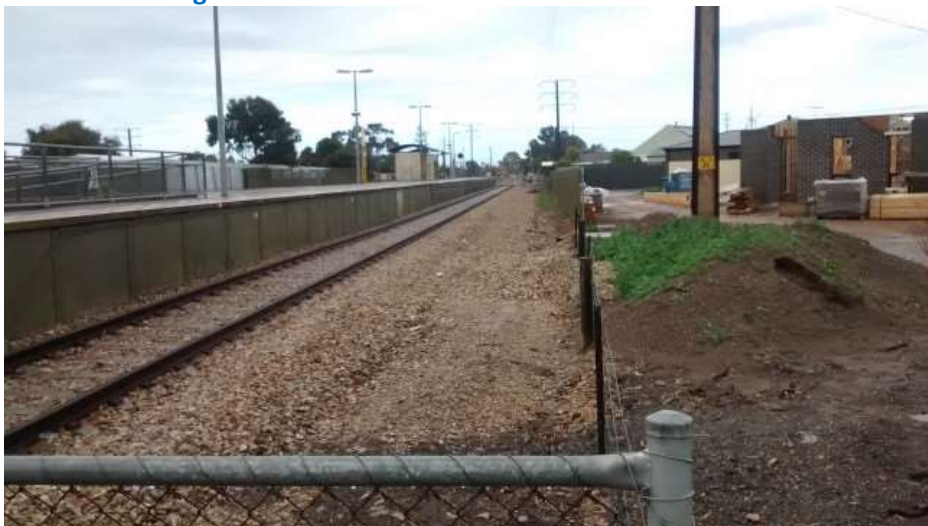
Photo 6. Fencing

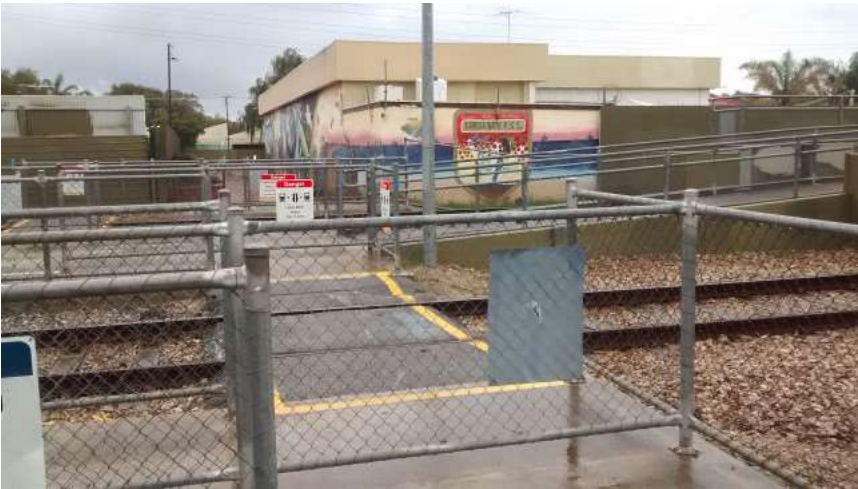
Photo 7. North East access

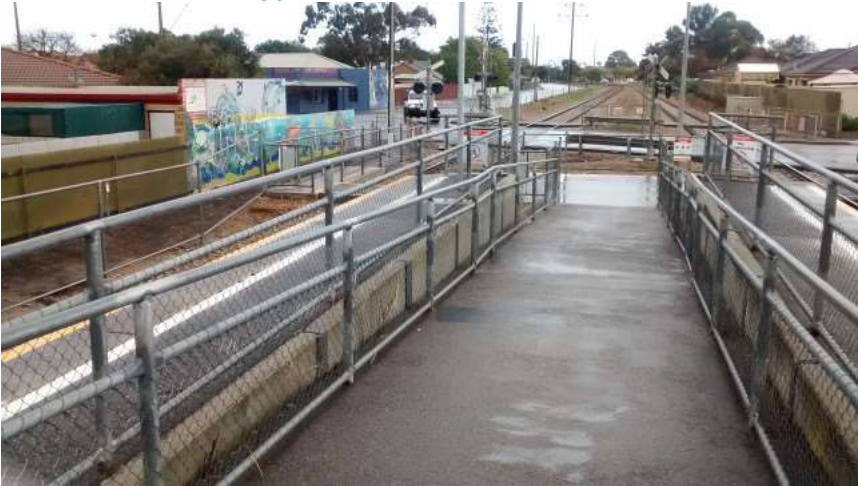
Photo 8. South East approach

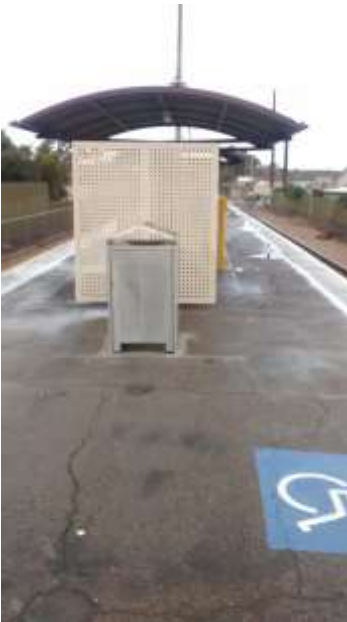
Photo 9. Shelter

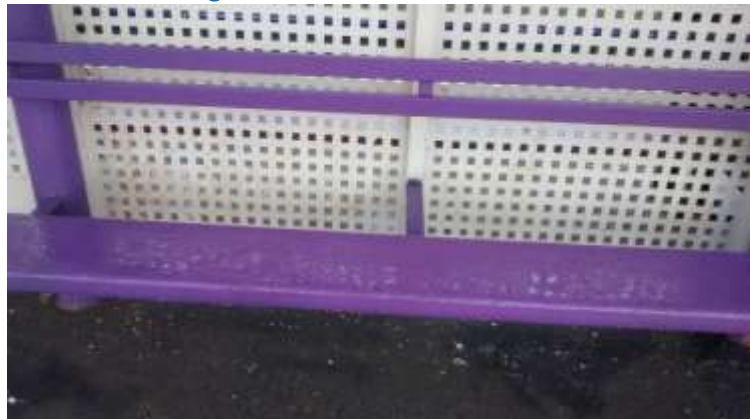
Photo 10. Seating

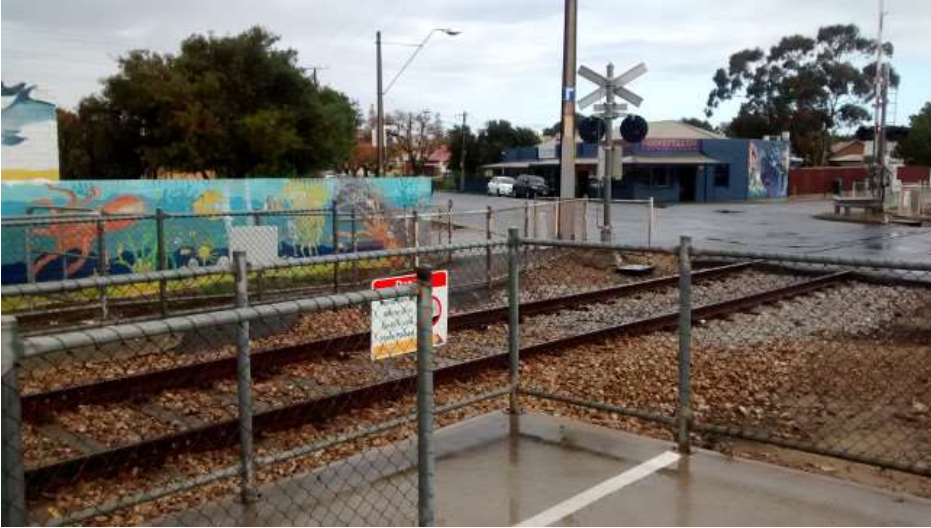
Photo 11. Art – southern side

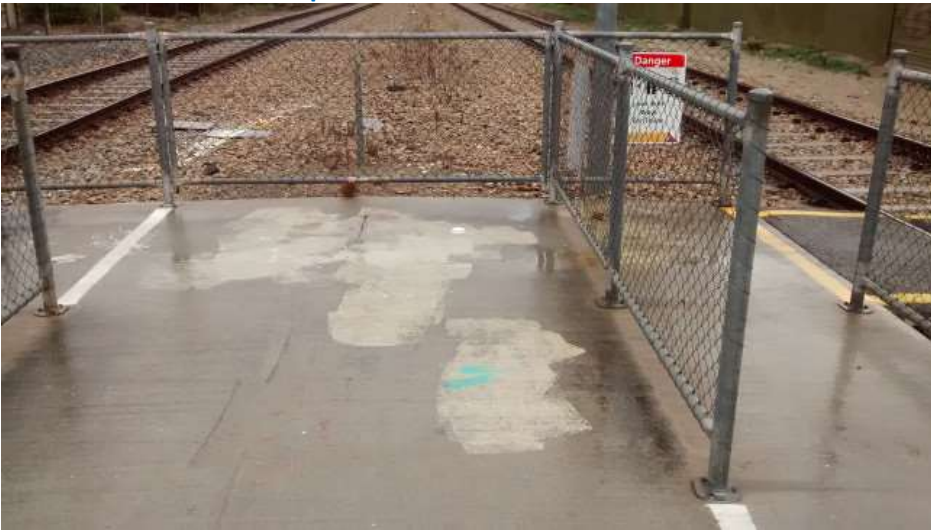
Photo 12. North East ramp

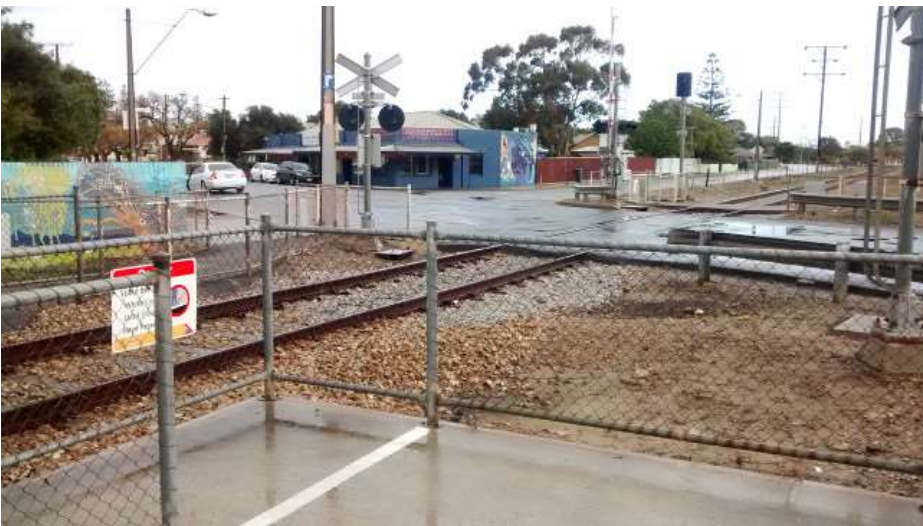
Photo 13. Café at South East
