Station Surveys – Outer Harbor Line – June 2016

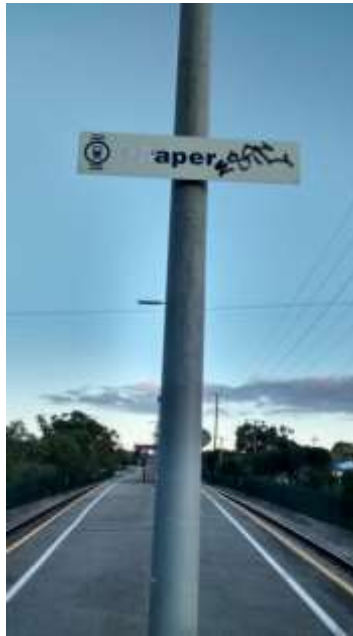
Photo 3. Graffiti on station sign

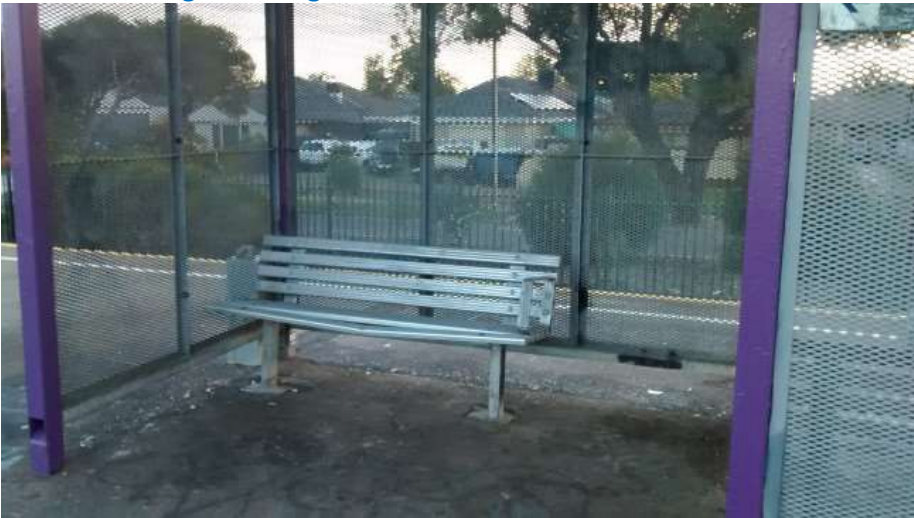
**Photo 6. Damaged seating**

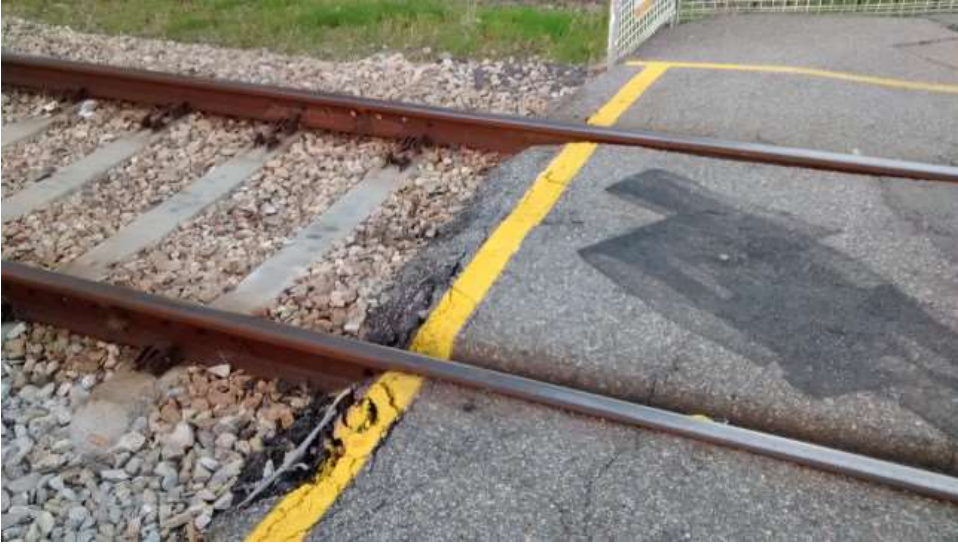
**Photo 9. Broken asphalt**
