Station Surveys – Outer Harbor Line – June 2016

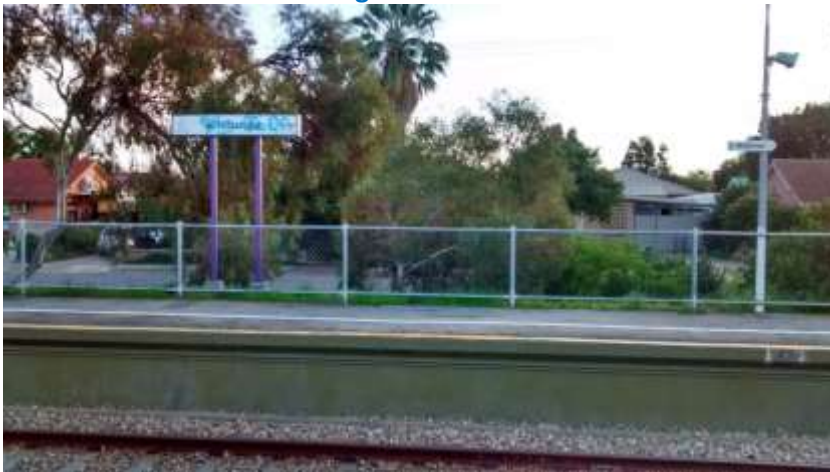
STATION	MIDLUNGA	
CRITERIA	SCORE (1 to 10)	COMMENTS
Appearance and Maintenance <ul style="list-style-type: none"> • Paintwork condition • Graffiti • Rubbish disposal • Cleanliness • Smells • Signage • Other 	3	<p>Multiple instances of graffiti over station name signage (Photos 2 and 3) and on the ground (Photo 4). Notably the timetable sign is fully painted over (Photo 5). Broken asphalt on eastern platform</p> <p>Clean, two small older style bins available. Station is generally clean, and no smells apparent.</p>
Security, Safety & Lighting <ul style="list-style-type: none"> • Emergency call phone • Security Cams • Hidden areas • Oversight by neighbours • Underpass • Pedestrian Gates • Lighting - on Approaches • Lighting - on Platform 	4	<p>No emergency phone is present. Security camera is built into PA post, but as it is not evident, cannot provide a visual deterrence. Fair oversight of both platforms by neighbouring residences (Photo 6).</p> <p>Lighting is adequate on both approaches and platform.</p>

Photo 2. Graffiti on station sign

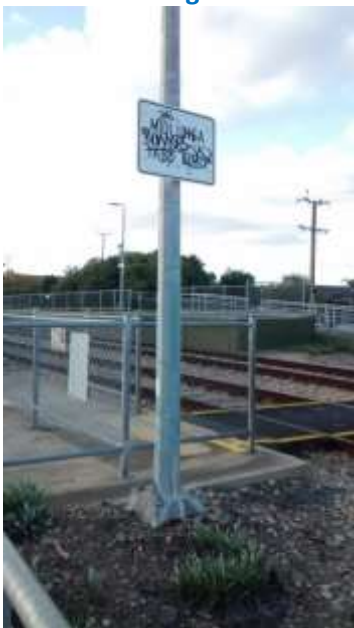
Photo 3. More graffiti

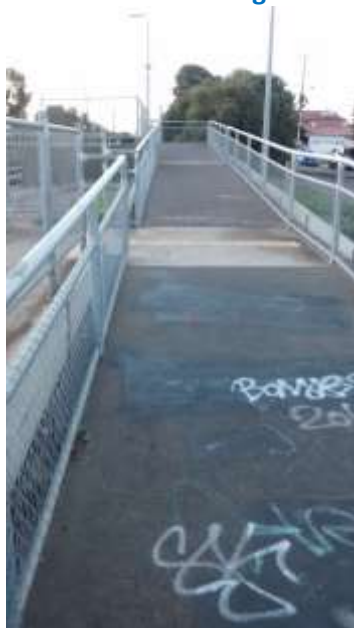
Photo 4. Even more graffiti

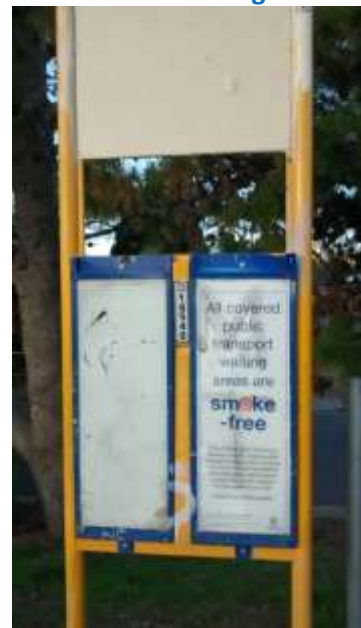
Photo 5. Timetable graffiti

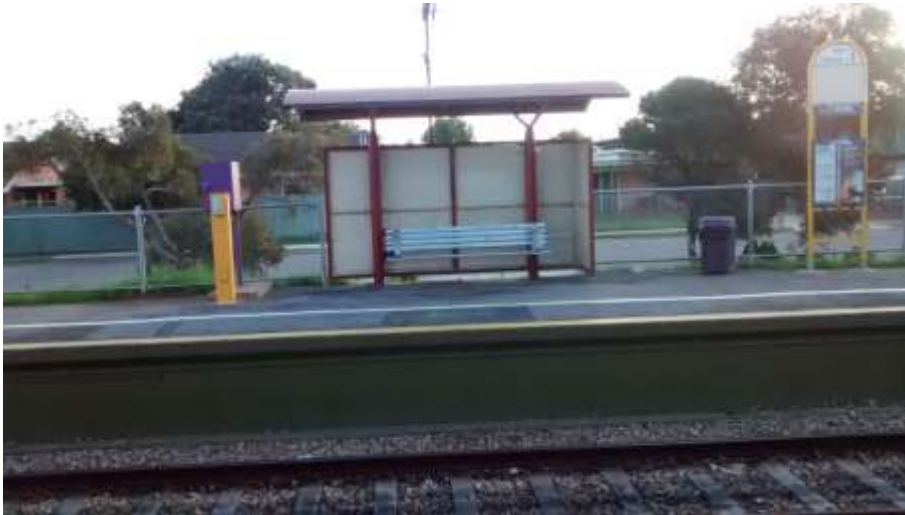
Photo 6.

Facilities <ul style="list-style-type: none"> • Toilets • Seats • Food • Shade and Rain Shelter 	2	<p>No toilets or other amenities on platform, or nearby. There is a minimum level of seating (Photos 6 and 10). The shelters are minimal shelters and offer no wind protection and poor rain protection. On the eastern side, half of the roof shelters overhangs the fencing and is inaccessible to passengers.</p>
Total Score / Overall Rating	3.2

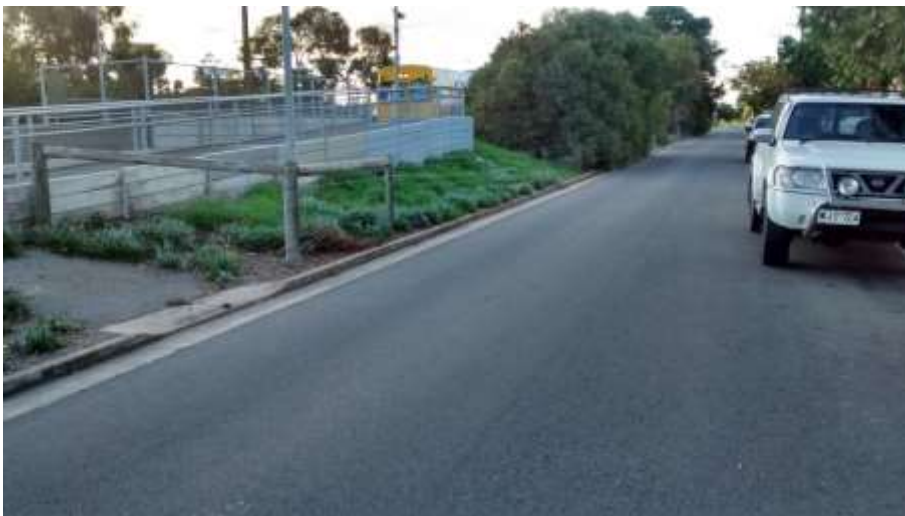
Car and Bike Parking <ul style="list-style-type: none"> • No of Spaces per Mode • Asphalt or gravel? • Bike chain-up secure? 	1	<p>No formal car parking spaces provided on either side of station. There is on-street parking only but the eastern side road is a narrow street and many spaces are taken up by residents (Photo 7). No bike racks provided.</p>
Disability Access <ul style="list-style-type: none"> • At Approaches • Ramps to platform • On platform 	6	<p>Southern approaches on both sides have excellent ramps with smooth paths, are wide and have a good gradient (Photos 8 and 11). Unusually, the path across the track is built of metal plate instead of the usual asphalt (Photo 9). It is not clear if the gap between track and plates would present an issue for wheelchair users. On the other hand, northern approaches are of minimal width and are of basic quality. The condition of the asphalt on the platforms may present issues (Photo 10). No disability access ramp on platforms.</p>

Photo 7. East parking

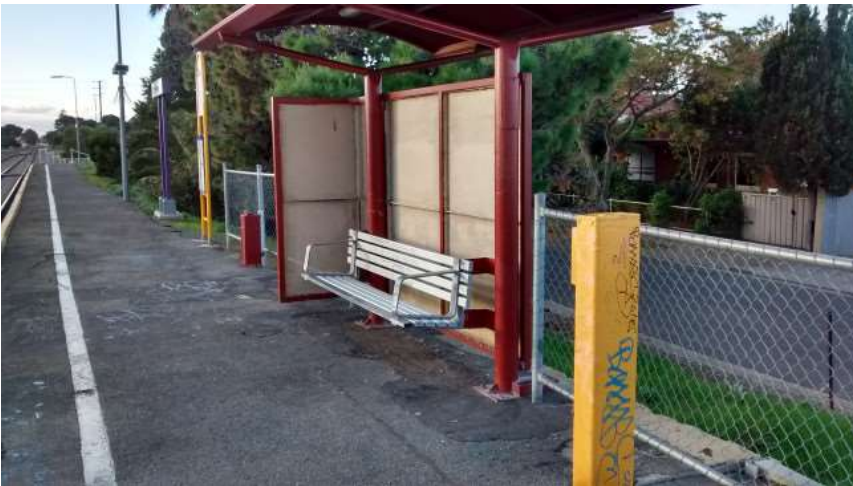
Photo 10. Shelter
