Station Surveys – Seaford Line – June 2016

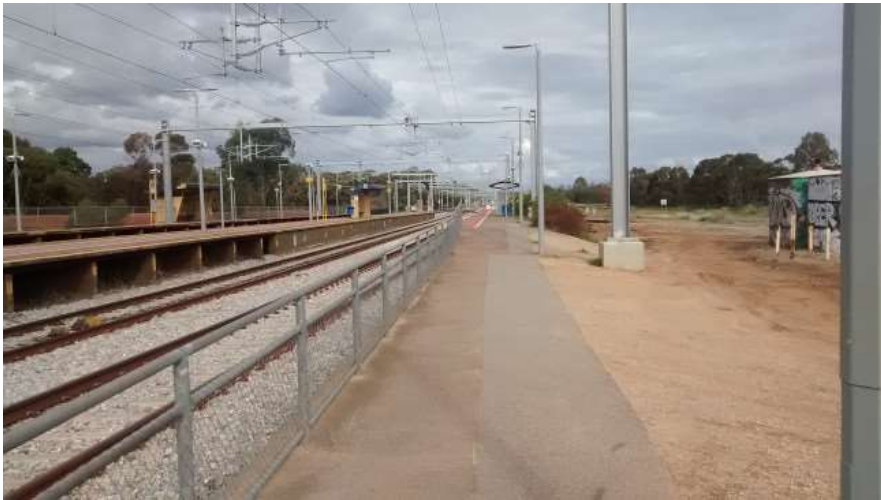
Photo 1.

<b>Facilities</b> <ul style="list-style-type: none"> <li>• Toilets</li> <li>• Seats</li> <li>• Food</li> <li>• Shade and Rain Shelter</li> </ul>	<b>2</b>	<p>No toilets or other amenities on platform, or nearby.</p> <p>Seating is basic in all shelters (<b>Photos 1, 2 and 5</b>).</p> <p>Platform 1 and 2 offer basic protection but, depending on wind direction, highly unlikely to be rainproof. The shelter on Platform 4 (<b>Photo 13</b>) is particularly unworthy of its name.</p>
<b>Total Score / Overall Rating</b>	<b>2.2</b>	
<b>Other Comments</b> <p>This station falls into the “New Siberia” category, in honour of its expanse across several passenger and freight lines, the lack of any amenity to speak of, its general isolation from almost any business, school or residence, and because the persons undertaking the survey most felt the wind chill factor at this station above any other.</p>

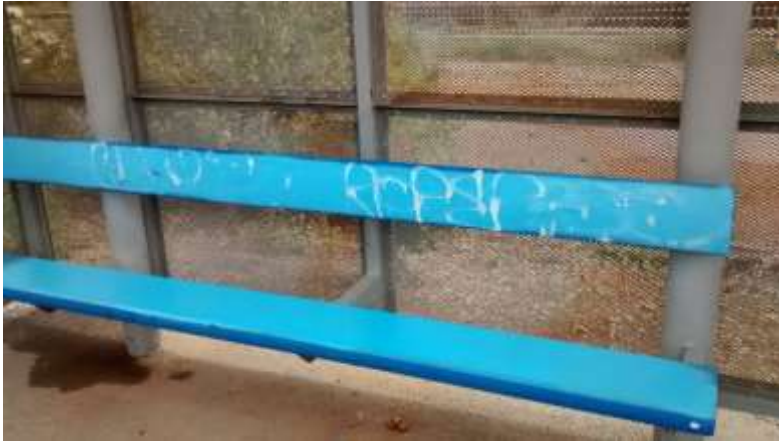
Photo 5. Graffiti on seat

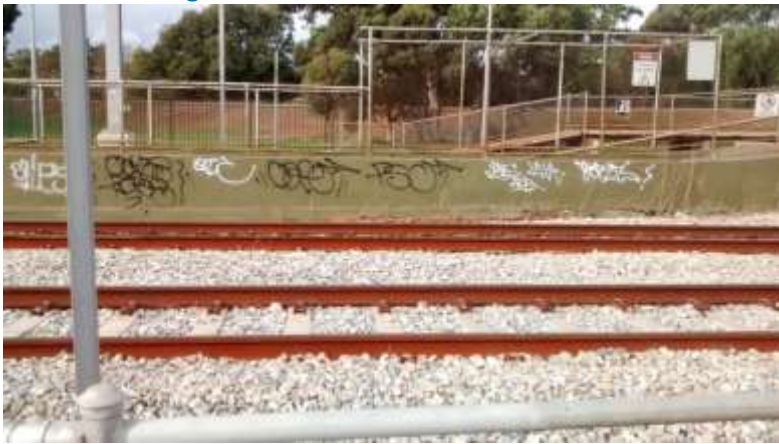
Photo 6. More graffiti

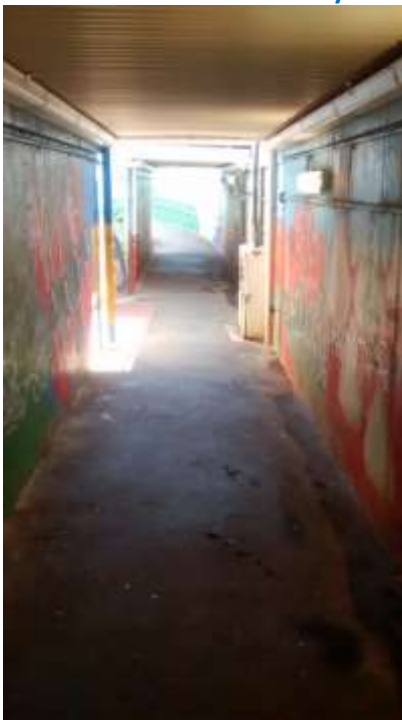
Photo 7. Pedestrian Subway

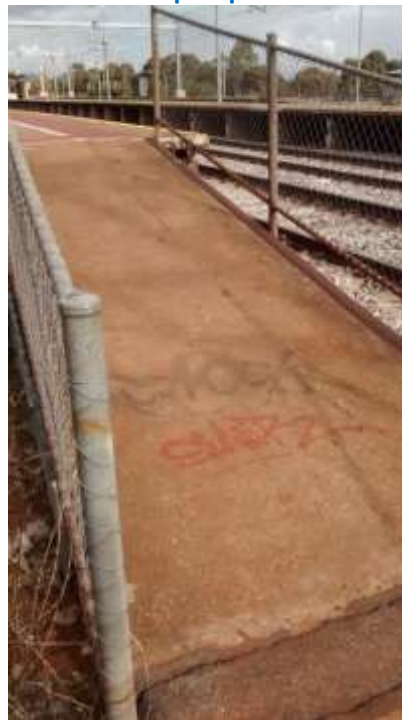
Photo 8. Ramp to platform 1

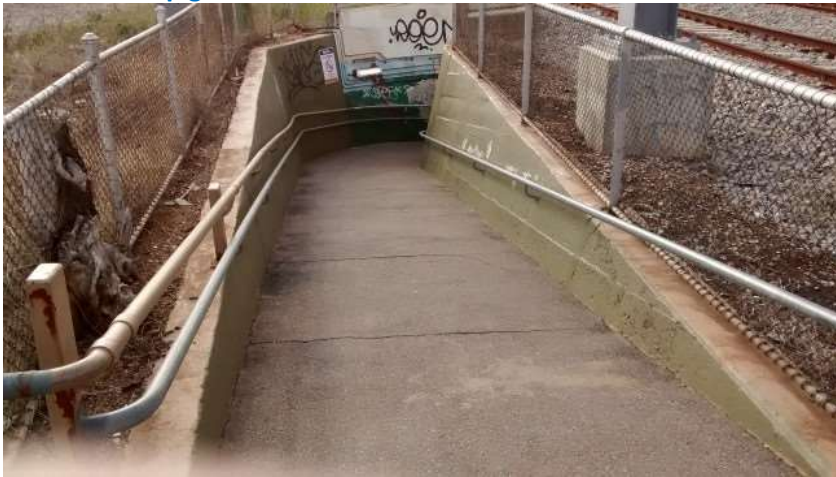
**Photo 9. Steep grade**

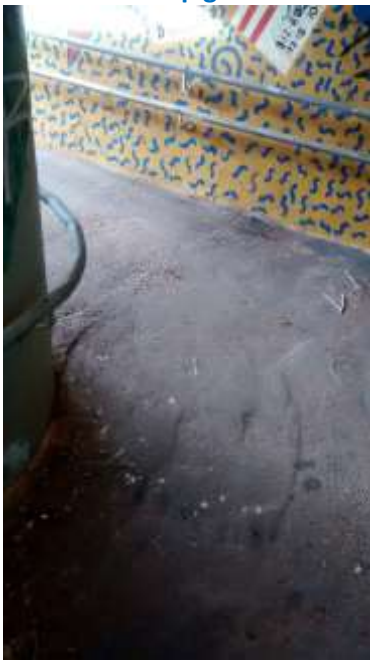
**Photo 10. Steep grade**

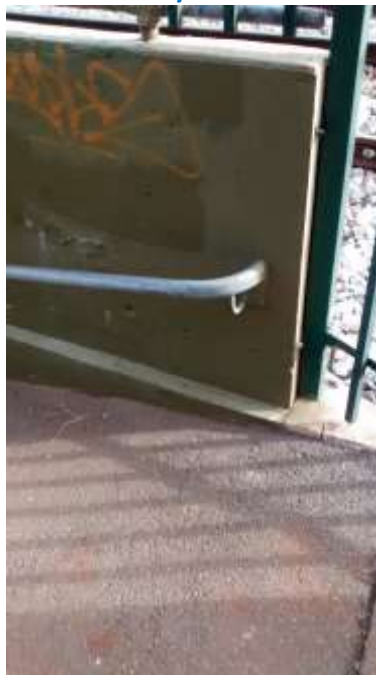
**Photo 11. Very low handrail**

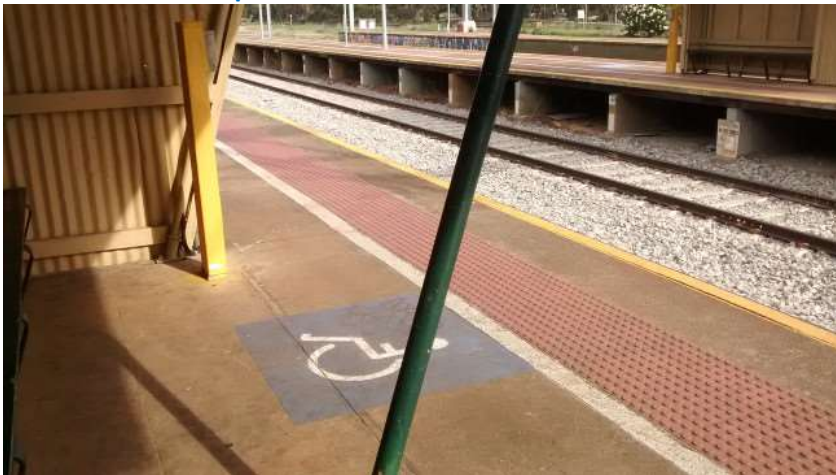
**Photo 13. Shelter platform 1**

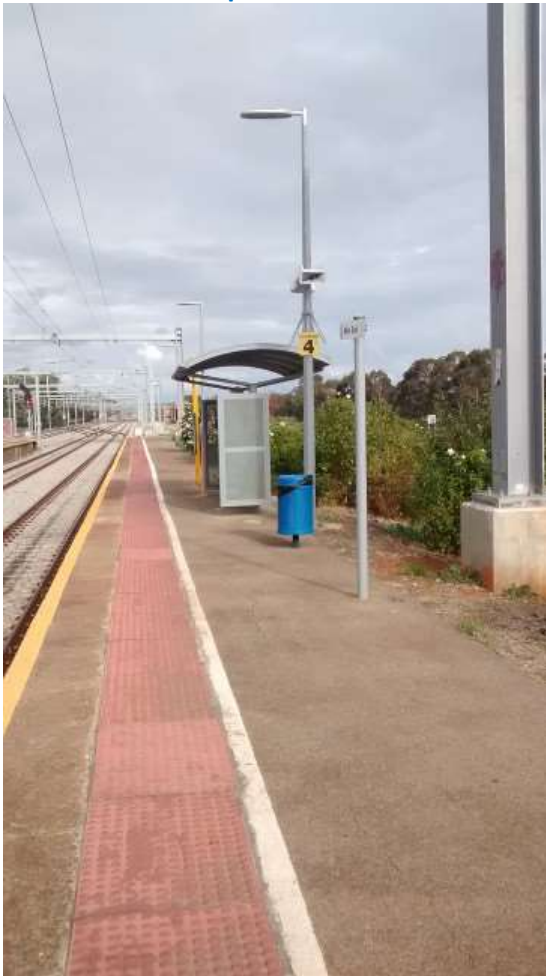
Photo 14. Shelter platform 4

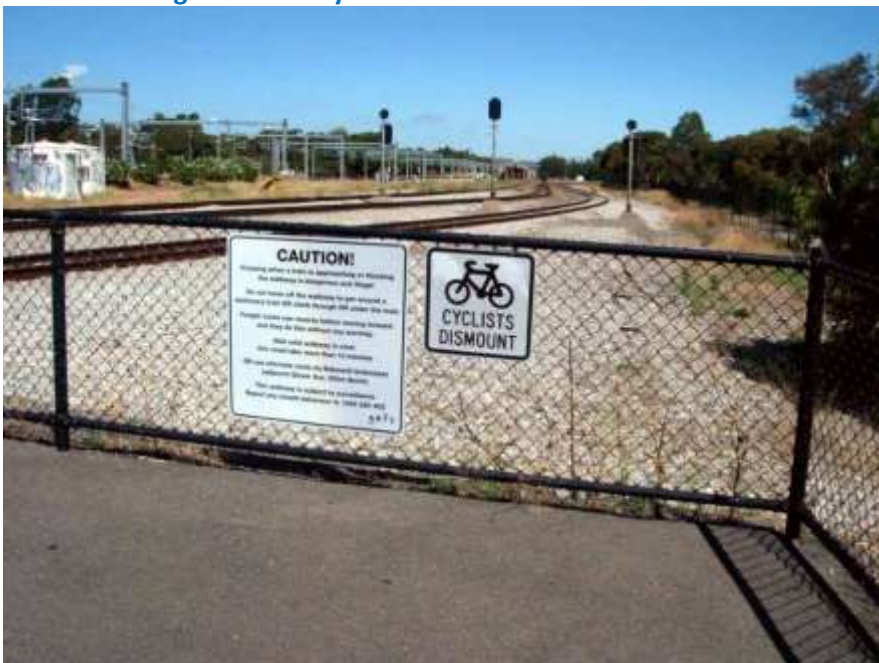
Photo 15. Freight line safety
