Station Surveys – June 2016

STATION	BOWDEN	
CRITERIA	SCORE (1 to 10)	COMMENTS
Appearance and Maintenance <ul style="list-style-type: none"> • Paintwork condition • Graffiti • Rubbish disposal • Cleanliness • Smells • Signage • Other 	7	Both café veranda and East side shelter need new paint. Some graffiti, mostly on northern shelter. Bins on both sides. Generally a clean environment, No smells. Station signs, timetables and line maps on both sides. Garden area reasonably well maintained.
Security, Safety and Lighting <ul style="list-style-type: none"> • Emergency call phone or button • Security cameras • Hidden areas • Oversight by neighbours • Underpass • Pedestrian gates • Lighting – Approaches • Lighting – Platform 	4	No emergency call phone or button and no visible security cameras. (cameras are hidden in the loudspeakers) A couple of areas hidden from public view behind the café (South side) and shelter (North side). No neighbours for any oversight to occur. Underpass: black paint to hide the graffiti, long, dark, dirty, rough and not at all inviting. (Photos 1 & 4) Pedestrian access; Boom gates on eastern side, zig zag fences on western side. Platform and station approaches l

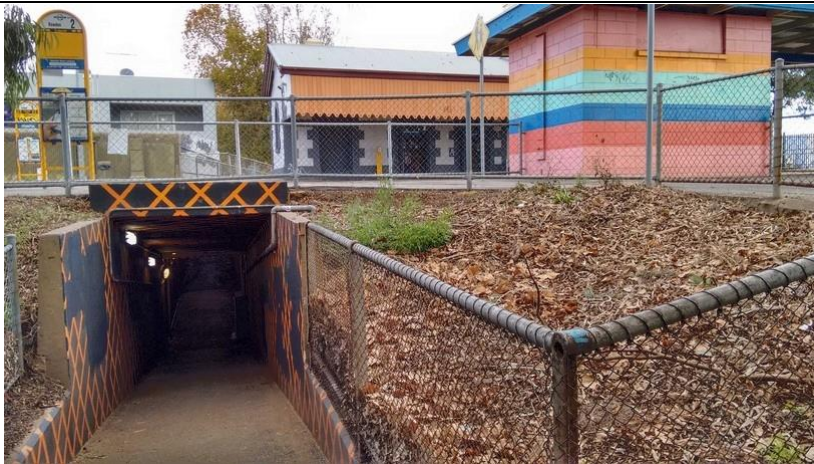
Photo 4.
The underpass is darker than the photos suggest.

(Photo light levels are enhanced in the photo to better show interior detail).

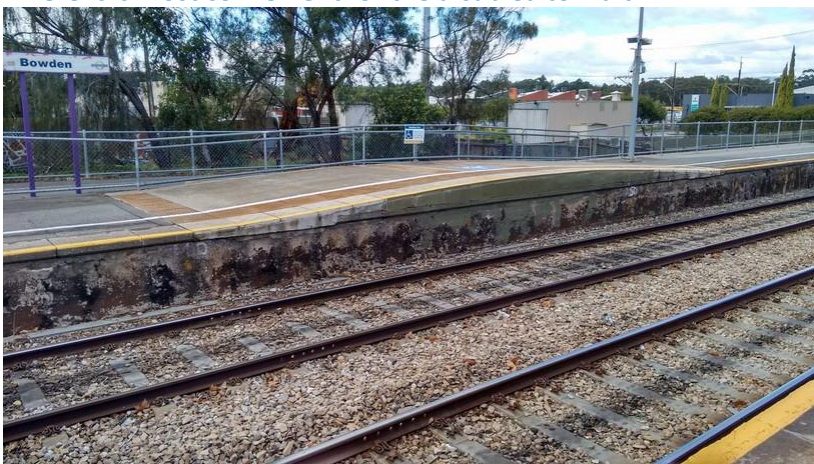
Photo 5. The raised area is disability ramp for wheelchair access to the trains – NO shelter where it is most convenient for the disabled to wait.

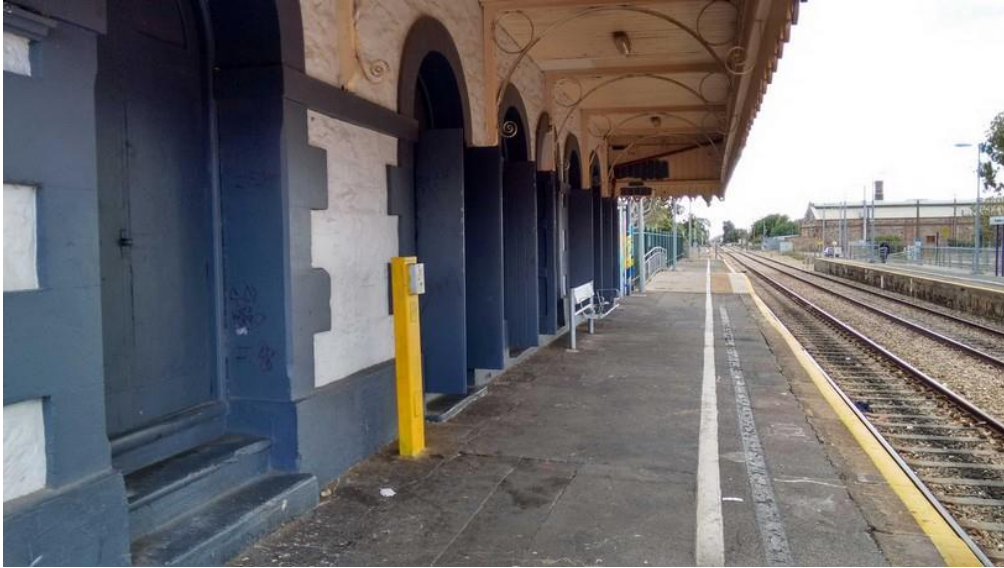
Photo 6. Heritage Building; Currently contains a popular café.
Could easily accommodate a lot more seating under this shelter space.

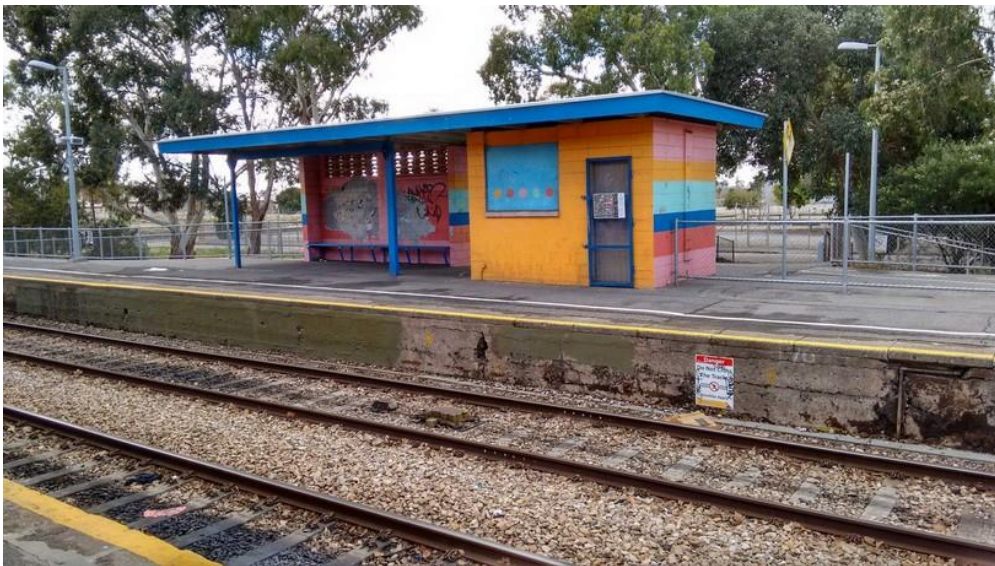
Photo 7. Not as good a shelter on the opposite side. Graffiti quite evident.
