Station Surveys – June 2016

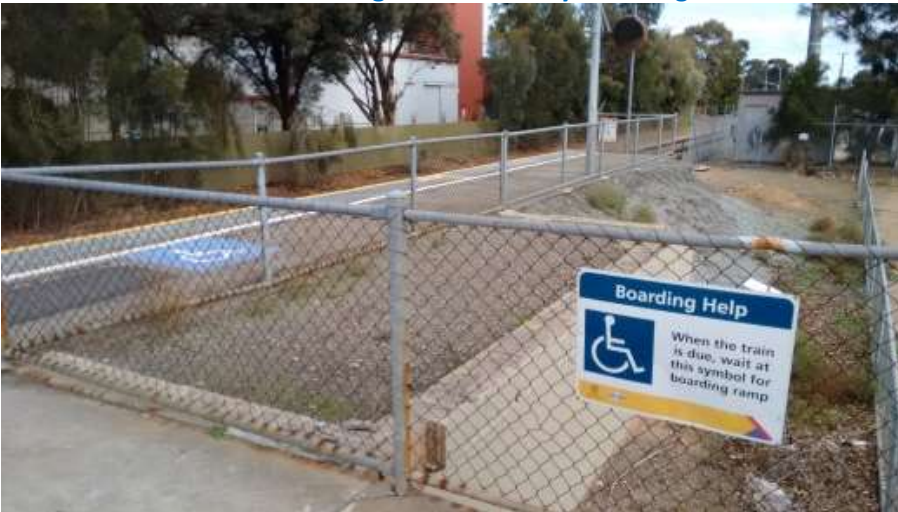
Photo 5. No shelter at the designated disability boarding area

Car and Bike Parking <ul style="list-style-type: none"> • No of Spaces per Mode • Asphalt or gravel? • Bike chain-up secure? 	3	On North side car parking makes use of gravel/dirt strip along station, with cars being parked in between trees; no delimitation between parking strip and road; also too narrow to allow safe walking to platform (one needs to walk on road) and too uneven for elderly or disabled. (Photos 1, 2, 4) South side: better car parking (asphalt) and has disabled parking, but on "wrong" side of platform. (Photo 7) No bike lockers or chain-up secure.
Disability Access <ul style="list-style-type: none"> • At Approaches • Ramps to platform • On platform 	3	North side: no disability access (see parking comment). From South side one needs to cross the track. Ramp to platform steep (too steep?), uneven and lopsided. No ramp on platform. Grange direction: disability boarding spot too close to barrier, not much room to manoeuvre.

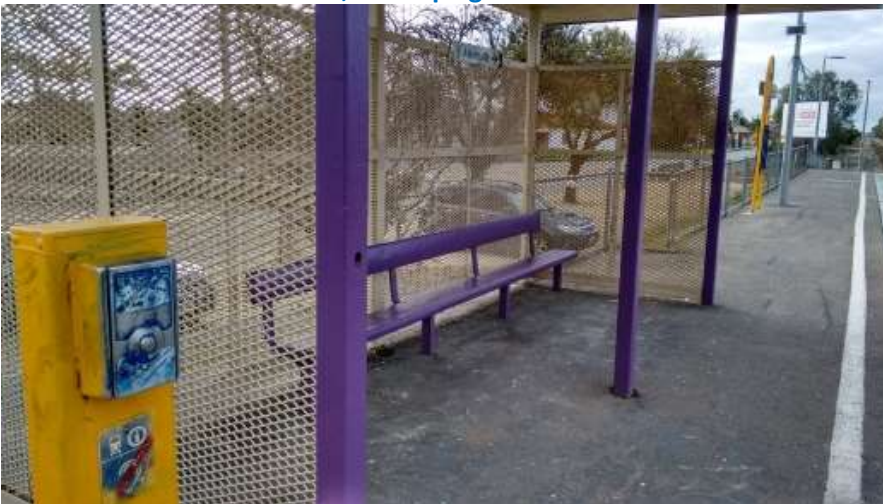
Photo 6. Steel mesh shelter , no help against a cold wind

Facilities <ul style="list-style-type: none"> • Toilets • Seats • Food • Shade and Rain Shelter • Loudspeakers • Ticket sale point 	3	8-10 seats + disabled space under shelter. Announcement button, clearly audible from close proximity, but loudspeaker is either too soft or does not work. Food at hotel, but on other side of road from station. Shade and rain shelter but no wind shelter. No toilets and no ticket sale point.
Averaged Score	2.9	
Other Comments:

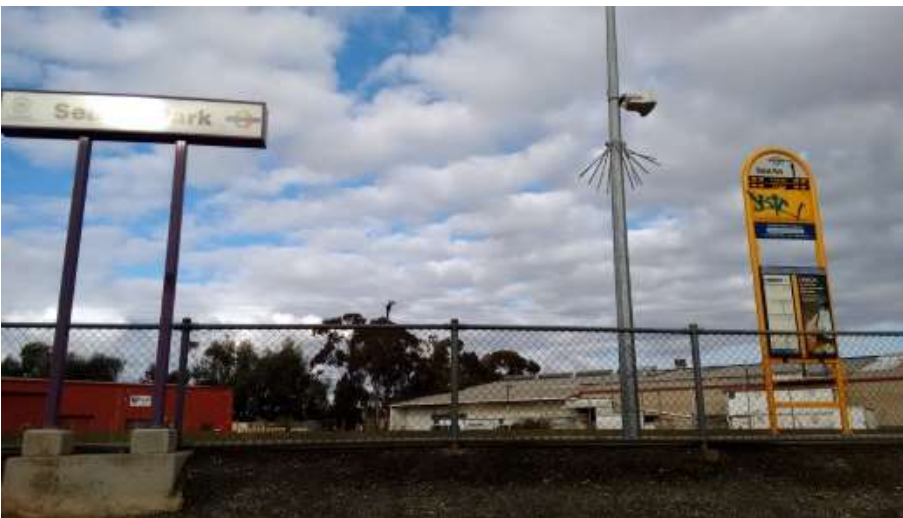
Photo 8.

Someone looking up at this sign from the carpark area below would find it impossible to read the print. (see photo 8)

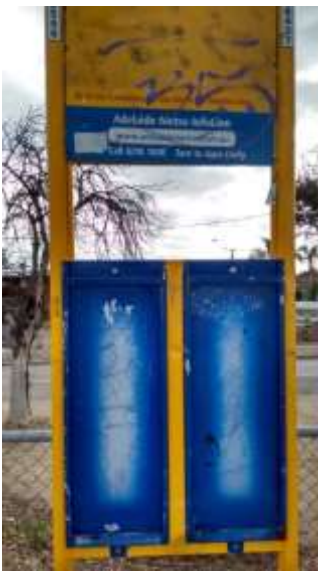
Photo 9. This station sign is right up against the platform fence. Timetable information is shown on the fence side of the panel.

It would be difficult for a person to squeeze into the space between the sign and the fence and so be attempt to read the timetable.
