Station Surveys – Outer Harbor Line – June 2016

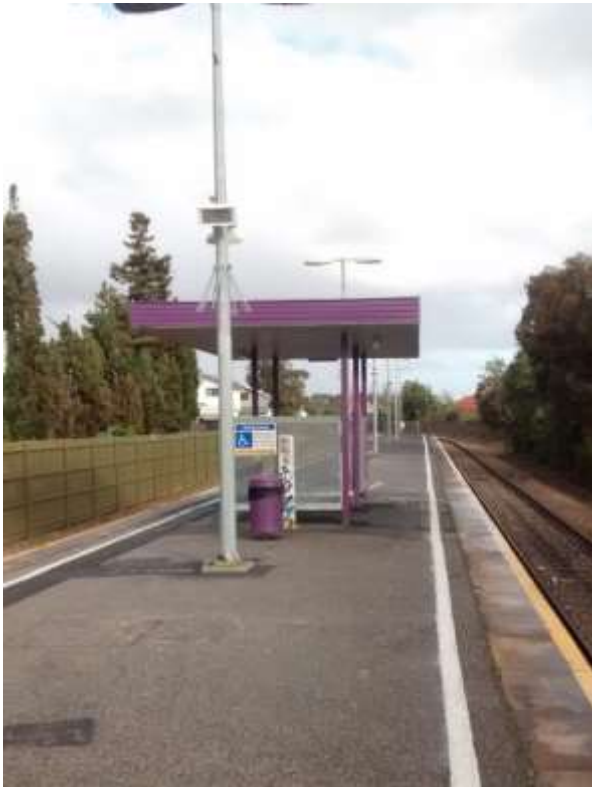
Photo 1.

STATION	PETERHEAD	
CRITERIA	SCORE (1 to 10)	COMMENTS
Appearance and Maintenance <ul style="list-style-type: none"> • Paintwork condition • Graffiti • Rubbish disposal • Cleanliness • Smells • Signage • Other 	3	<p>Some graffiti on timetables which in this instance obscures some of the information (Photo 3). Also graffiti on the seating (Photo 11).</p> <p>As advised by patron, fence on eastern side recently repainted to hide graffiti. Similarly, the main station sign was recently cleaned up (Photo 2).</p> <p>One older style rubbish bin (Photo 1).</p> <p>The station was generally clean, and no smells were apparent.</p>
Security, Safety & Lighting <ul style="list-style-type: none"> • Emergency call phone • Security Cams • Hidden areas • Oversight by neighbours • Underpass • Pedestrian Gates • Lighting - on Approaches • Lighting - on Platform 	3	<p>No emergency phone is present.</p> <p>Security camera is built into PA post, but as it is not evident, cannot provide a visual deterrence.</p> <p>No oversight of the platform from either the eastern side (Photo 4) or most of the western side (Photo 5), due to number of hedges and trees. There are a number of houses immediately adjacent to the car park and this well overseen by neighbours (if at home).</p> <p>Lighting is adequate on the platform but approaches only have minimal street lighting.</p>
